**Matlang Kdonglapathah FIP**

**TOUR NOTES/INSPECTION UNDERTAKEN BY SHRI.P.L.NONGBRI, SRO AND SHRI.E.B.LYNGDOH, ARO  
IN RESPECT OF IRRIGATION PROJECTS IN JAINTIA HILLS ON THE 24<sup>TH</sup> TO 26<sup>TH</sup> FEBRUARY 2005.**

**IULAMBHOI FIP**

**UMSEMA FIP**

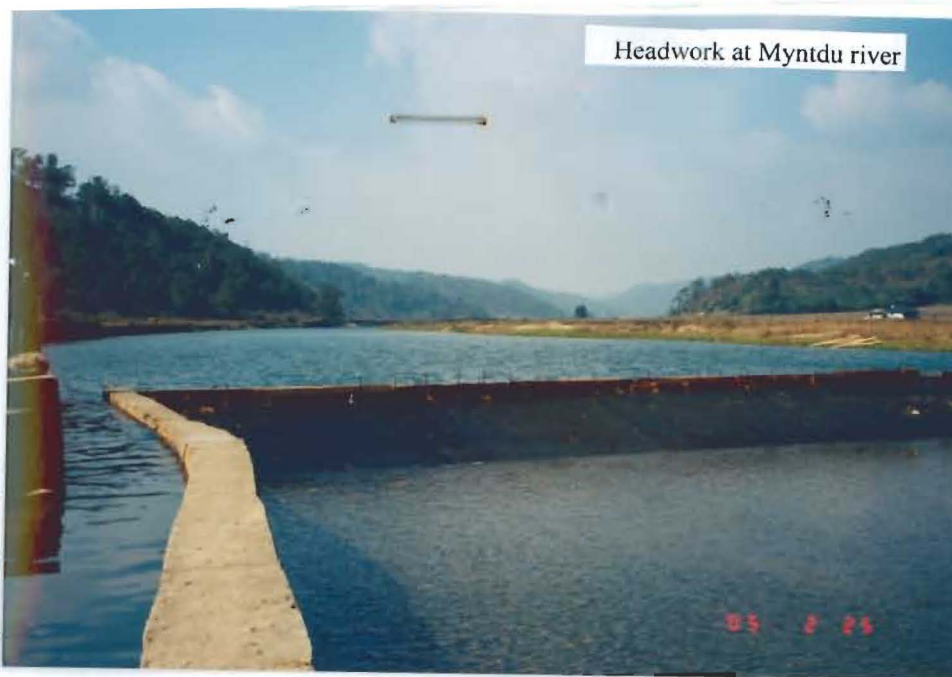
The Headwork is constructed across the Myntdu river and its span is 44.00Rm. The height/depth of the headwork is 1.5m. Height of the headwork is temporarily raised with the help of wood. Part of the headwork is slightly damaged by flood erosion. Height of the headwork could not be raised due to objection by the farmers due to fear of floods during monsoon

Headwork at Myntdu river

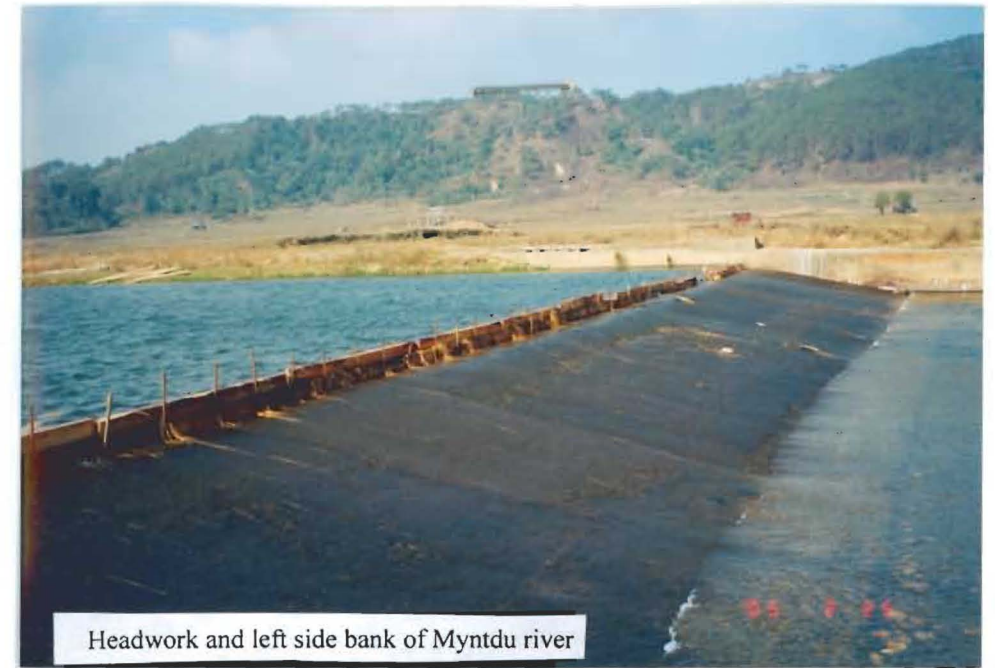
Headwork and left side bank of Myntdu river

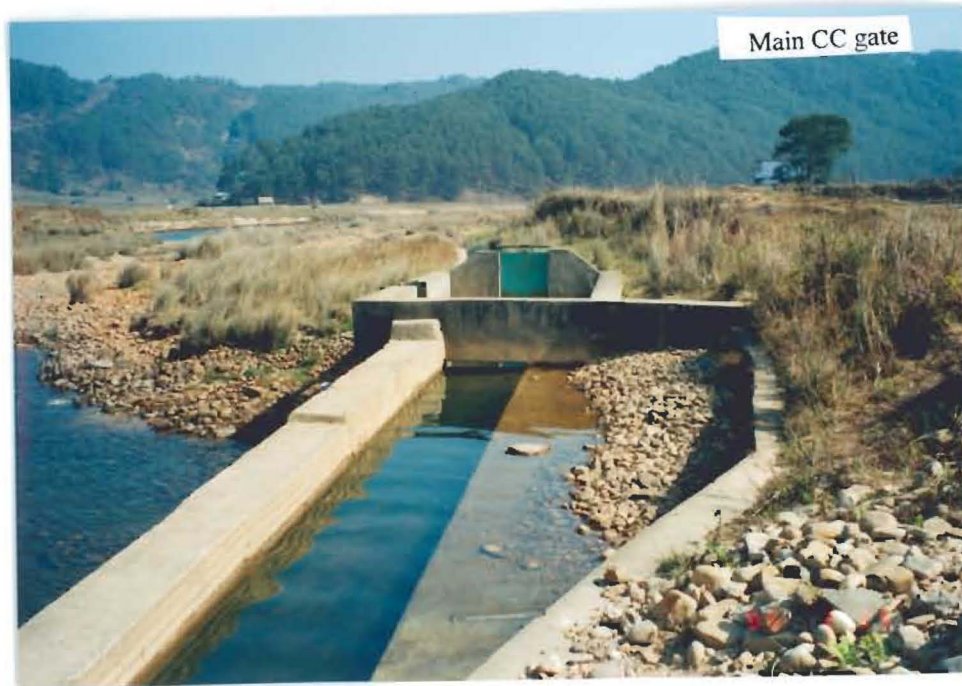
Main CC gate

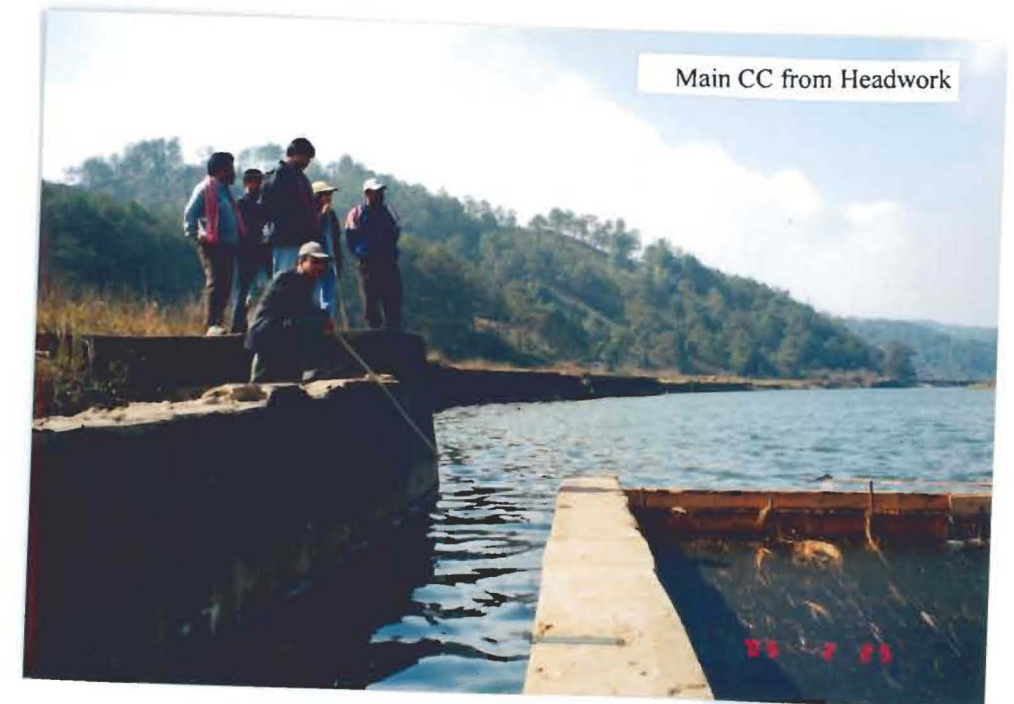
Main CC from Headwork

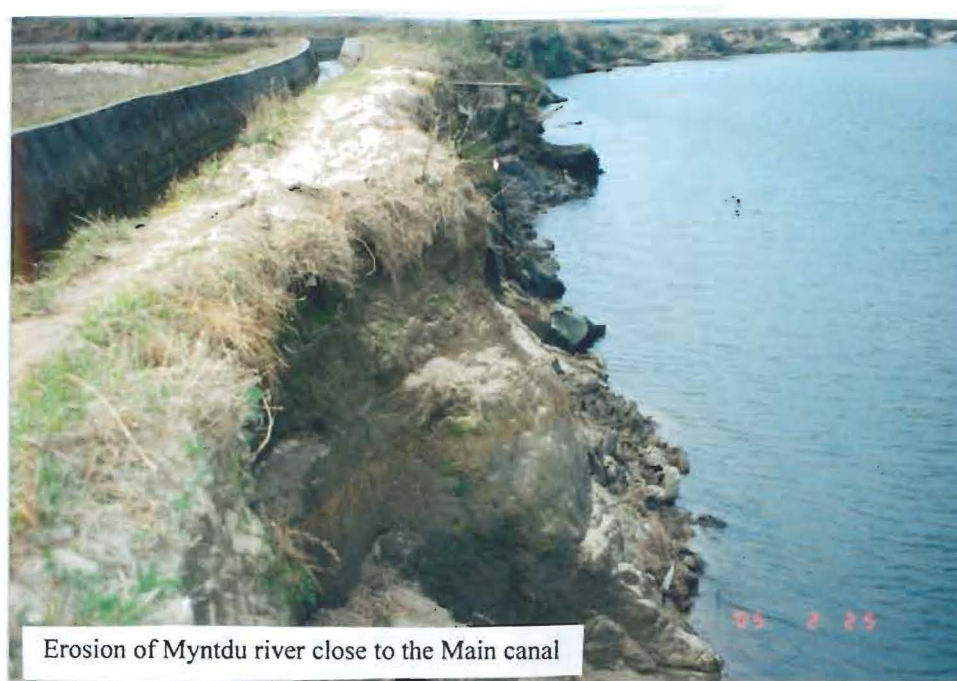
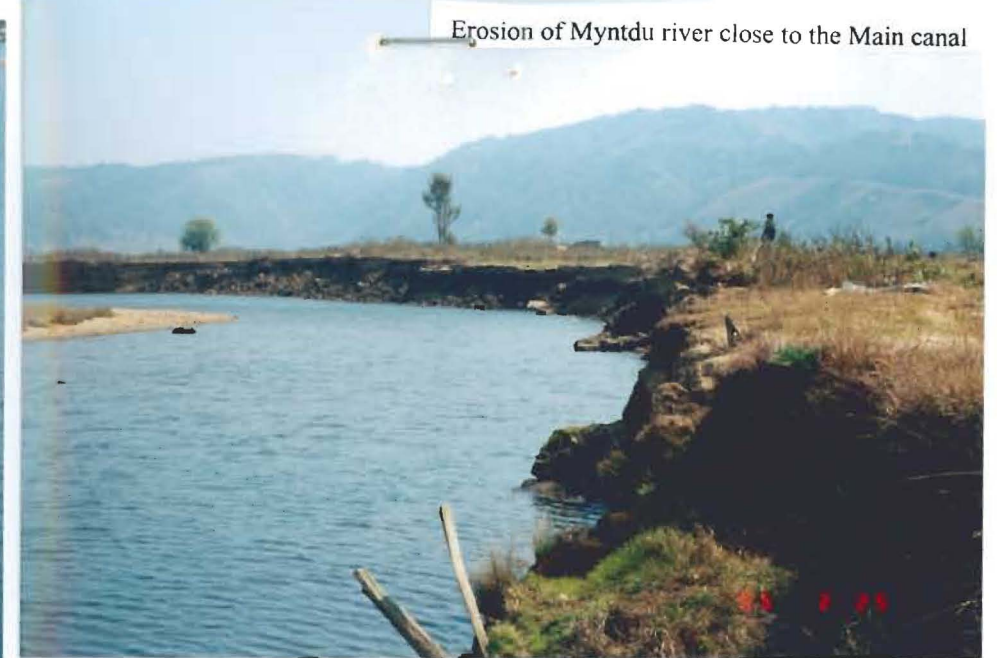
Due to erosion of the Myntdu River during the first week of October 2004 a portion of the main canal (about 200 Rm) is likely to be damaged/collapsed unless a retaining wall is constructed. At present erosion is temporarily protected with

Erosion of Myntdu river close to the Main canal

1. Supporting/Retaining wall (200 Rm) due to erosion of the Myntdu River is urgently required to be constructed before the coming monsoon to prevent collapse of the main Canal. Keeping in view the big amount involved, PWD may perhaps be approached for funding under Flood Control. Irrigation Department may also explore the possibility to divert the main canal by offering compensation to the beneficiary concerned.

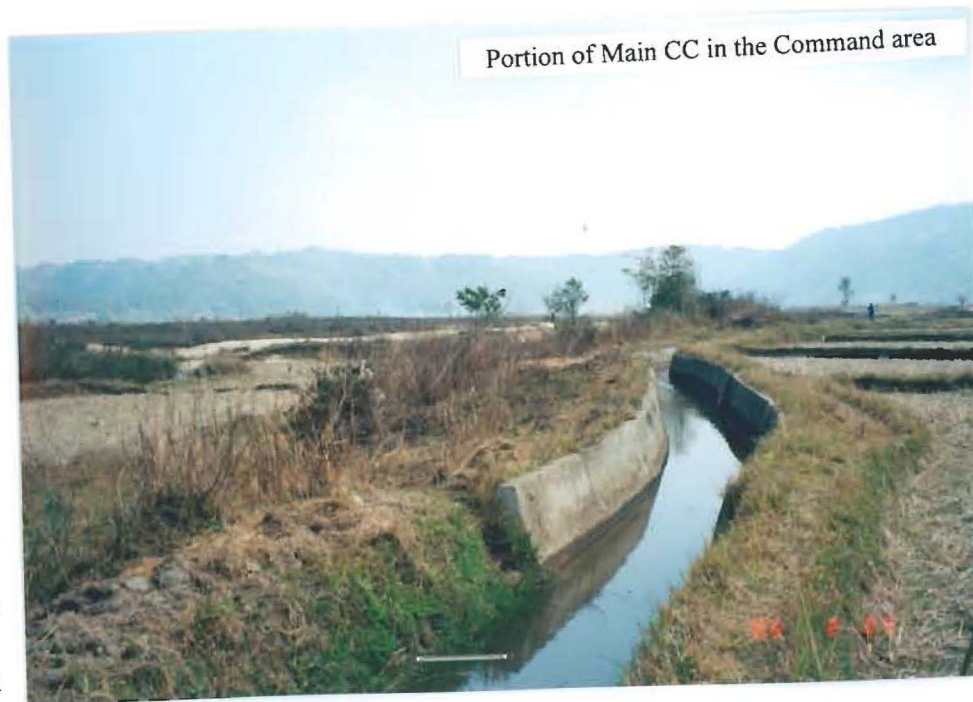
Portion of Main CC in the Command area

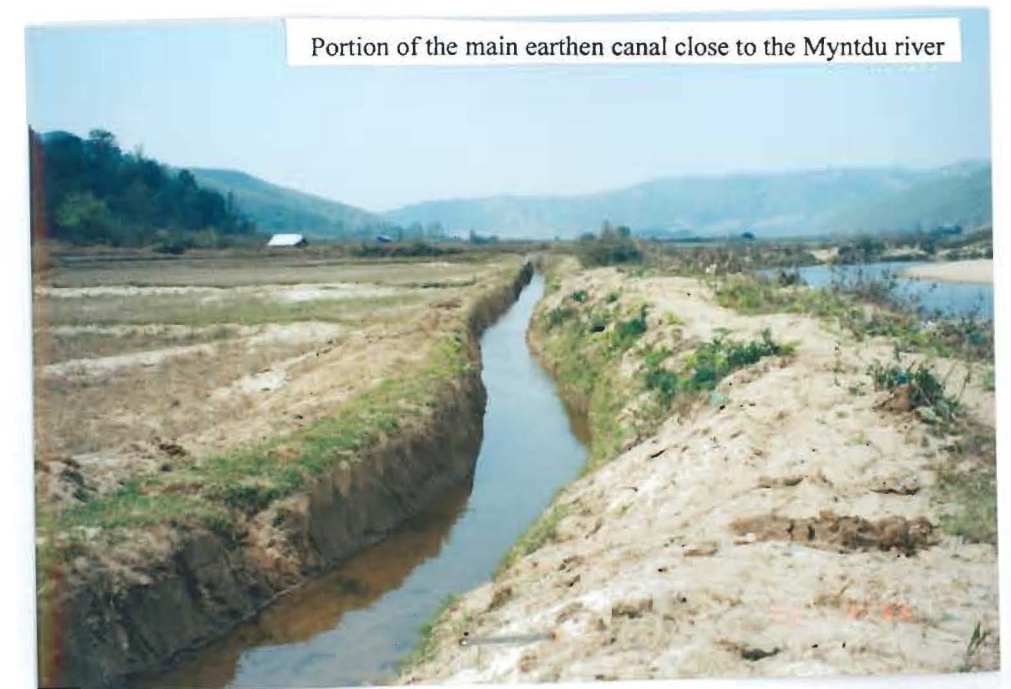
Portion of the main earthen canal close to the Myntdu river

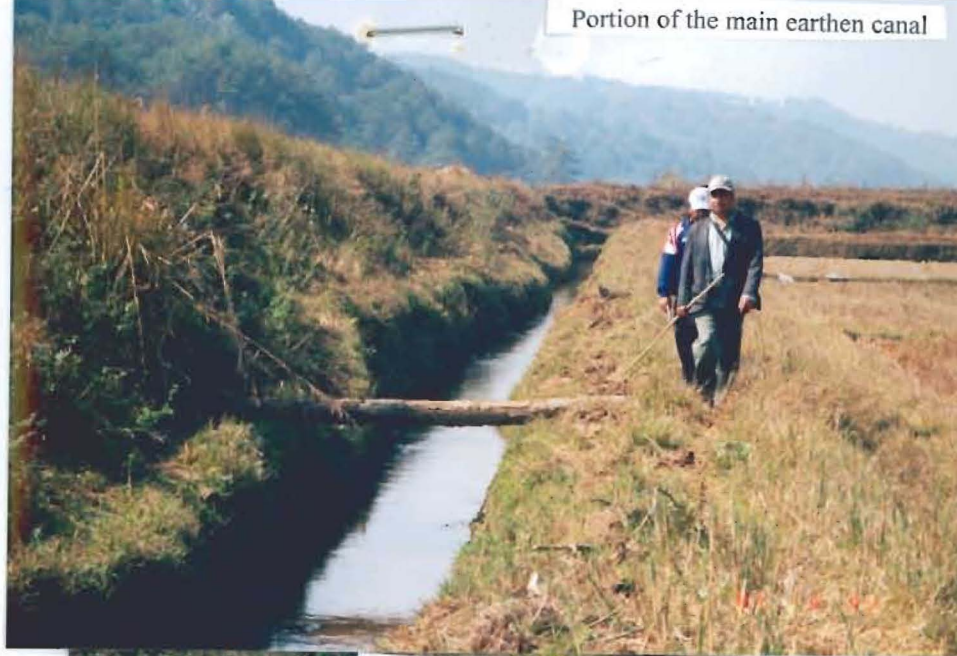
Portion of the main earthen canal

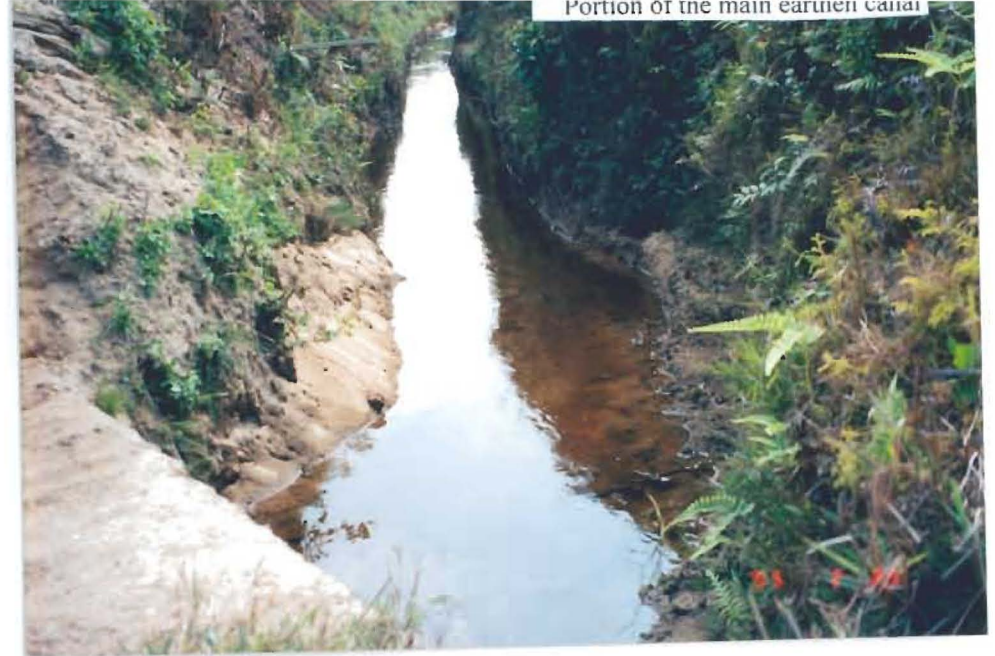
Portion of the main earthen canal

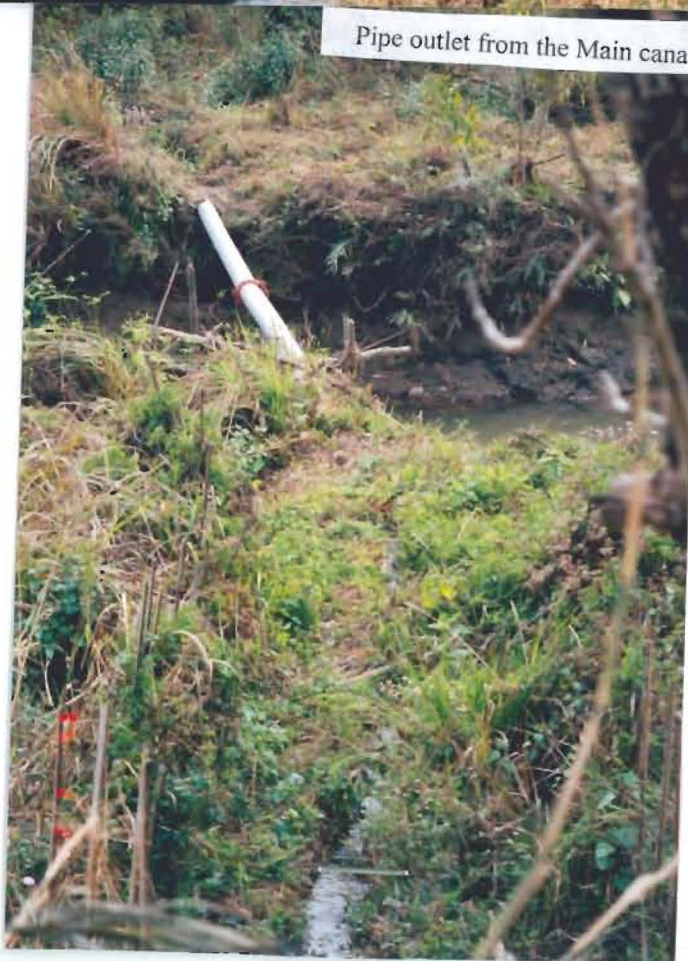
Pipe outlet from the Main canal

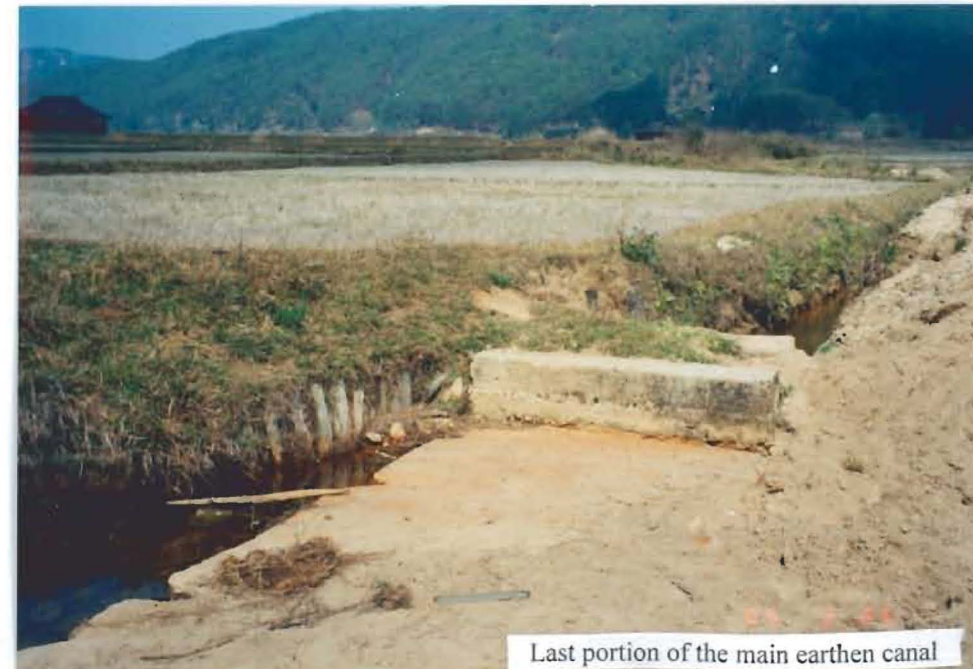
Last portion of the main earthen canal

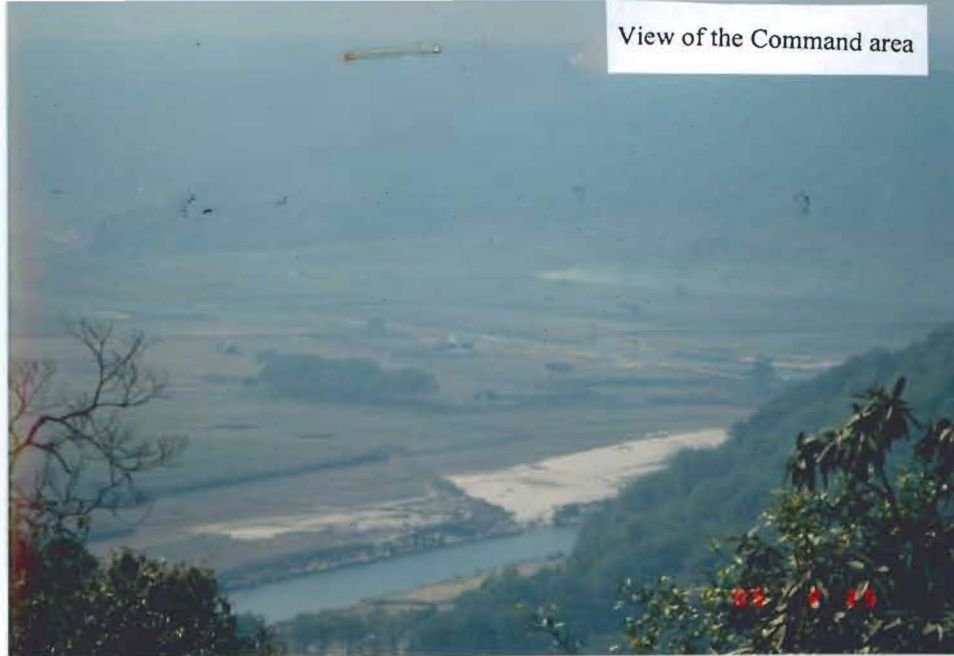
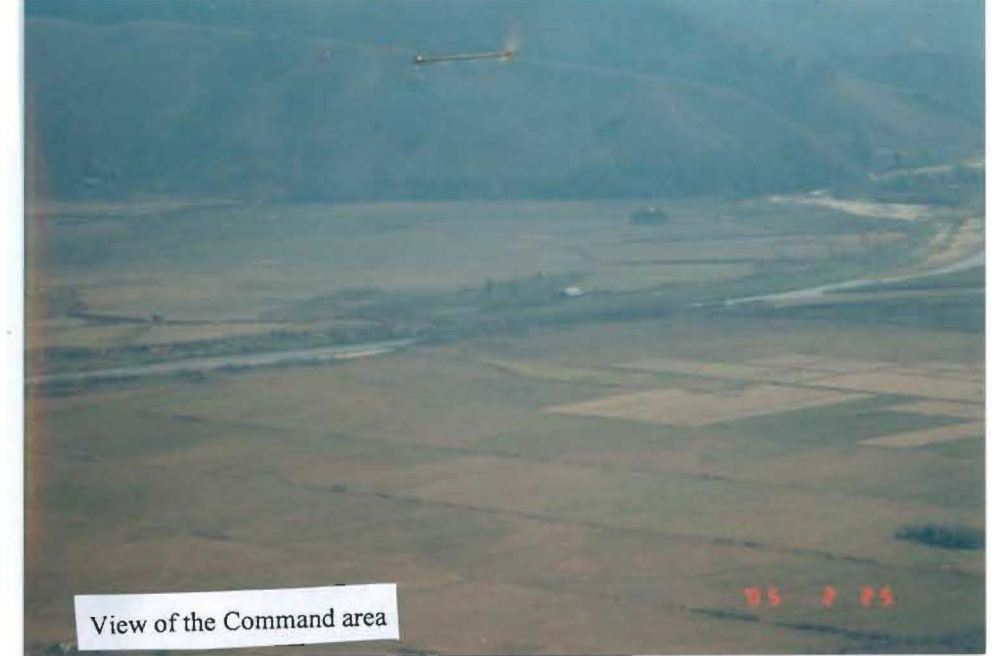
View of the Command area

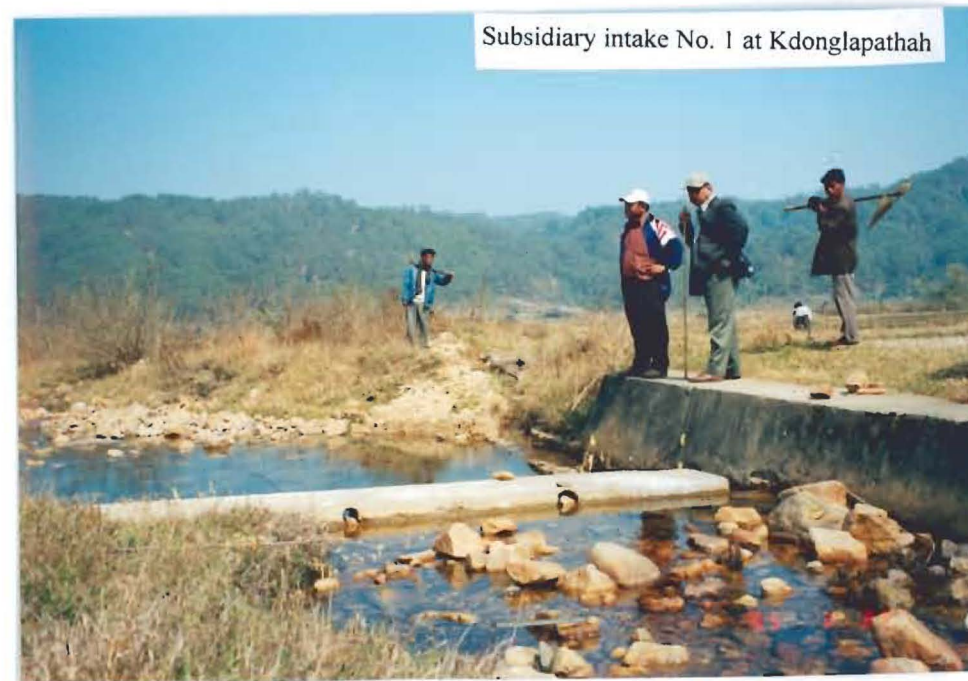
Subsidiary intake No. 1 at Kdonglapathah

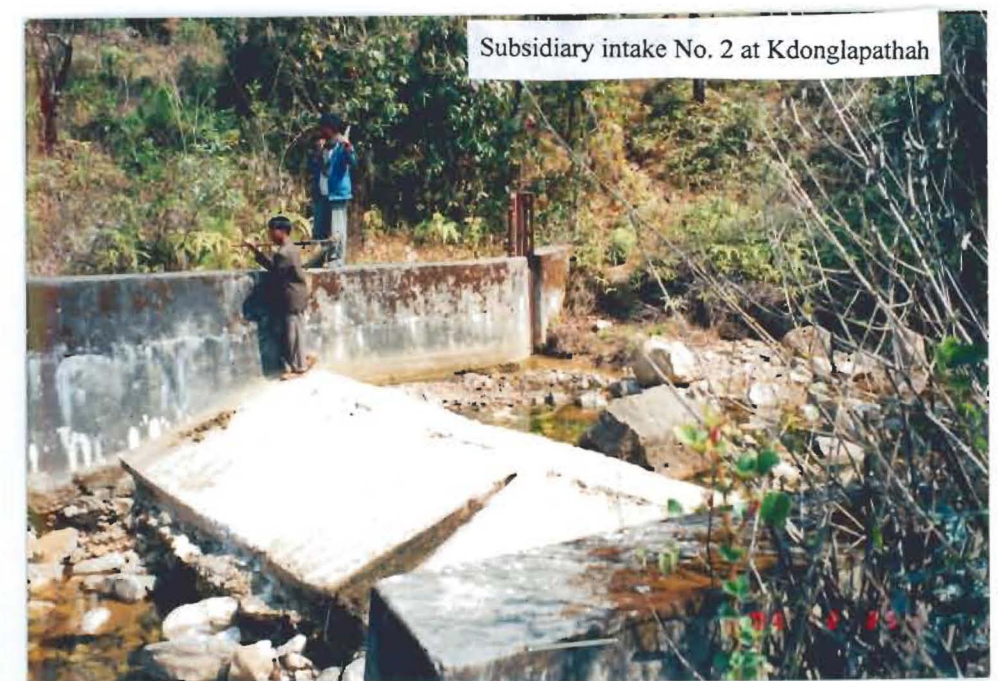
Subsidiary intake No. 2 at Kdonglapathah

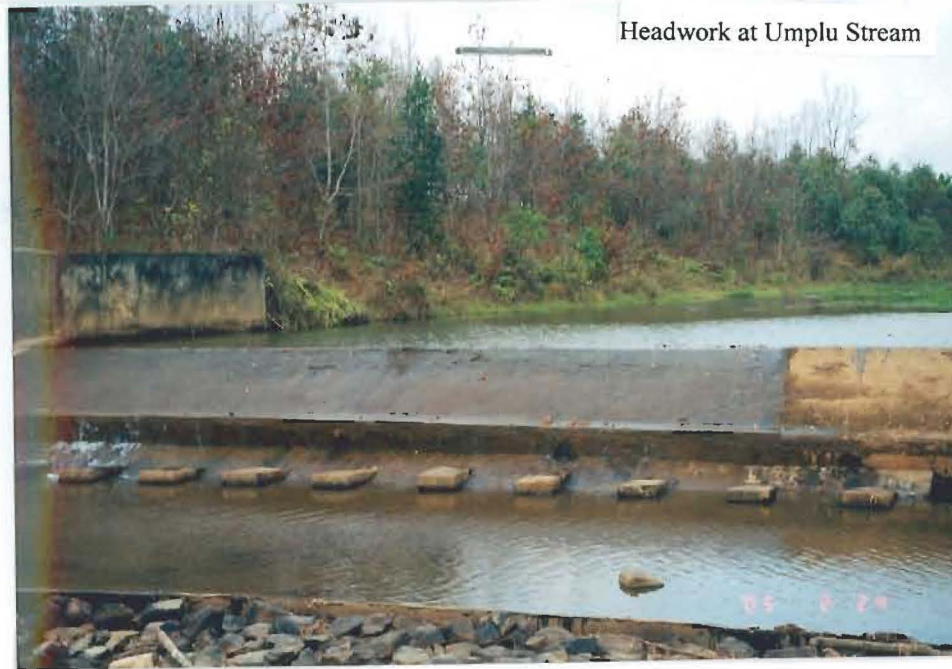
Headwork at Umplu Stream

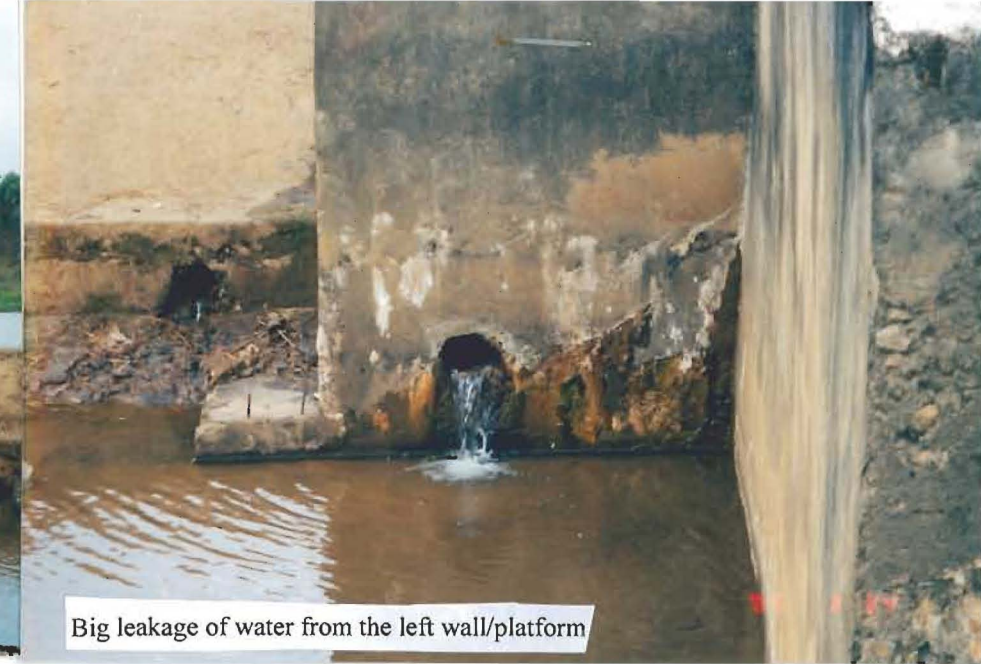
Position of the Headwork is in good condition except the **left side wall/platform of the Headwork that has been damaged during the flash floods** last year during the first week of

October 2004 and as a result a big hole has been developed from which there has been a big leakage of water. This portion is becoming very weak and needs to be immediately repaired before the coming monsoon otherwise the whole portion/platform will be washed away.

Big leakage of water from the left wall/platform

3. Immediate necessary action is required for repairing / renovation the **left side wall/platform of the headwork** before the coming monsoon otherwise the entire portion will be washed away.

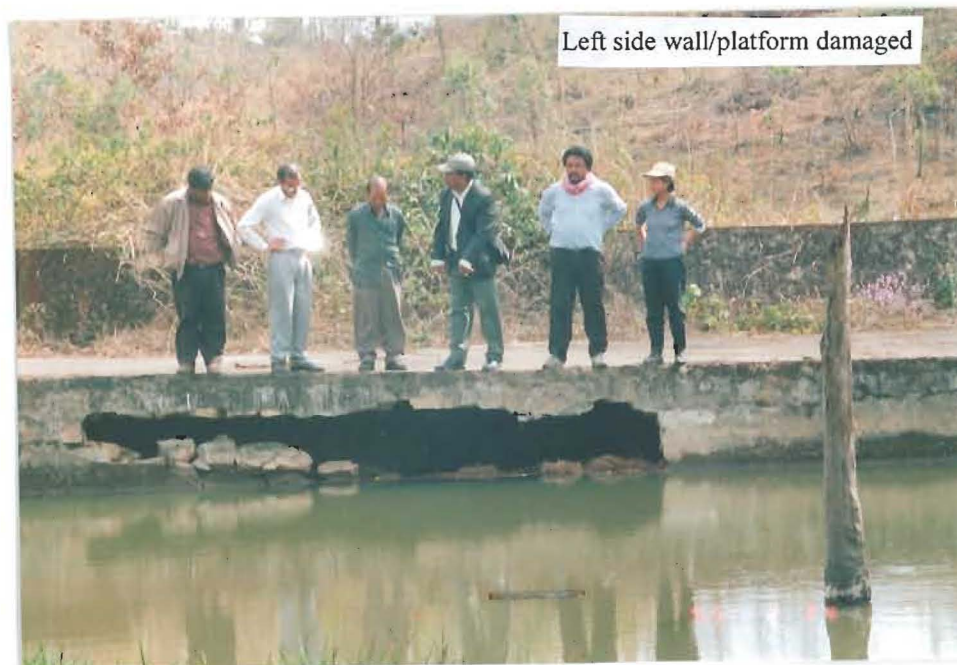
Left side wall/platform damaged

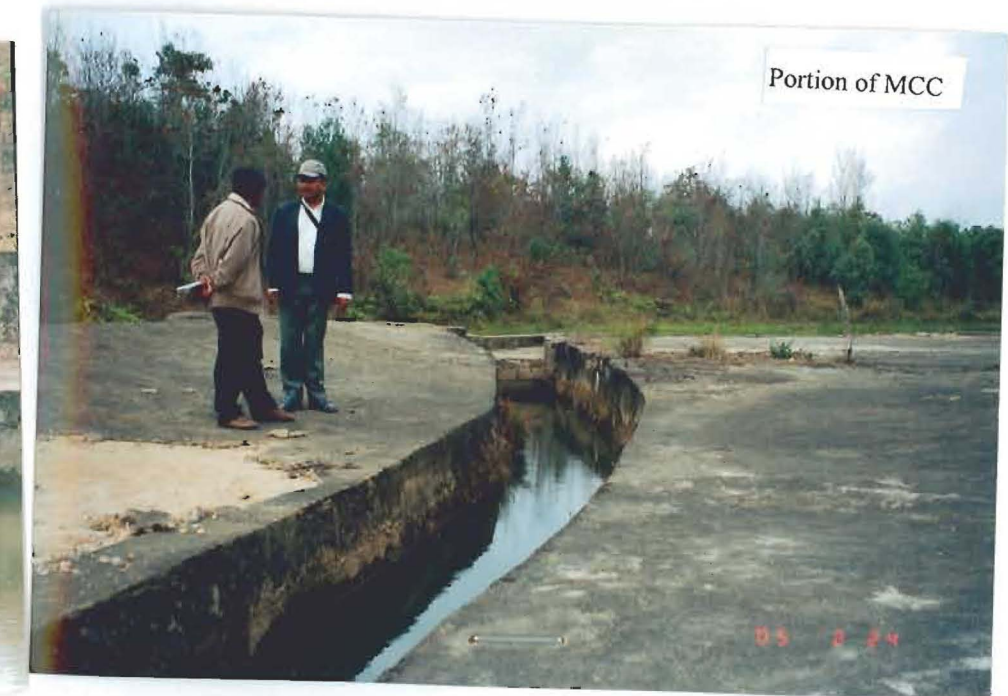
Portion of MCC

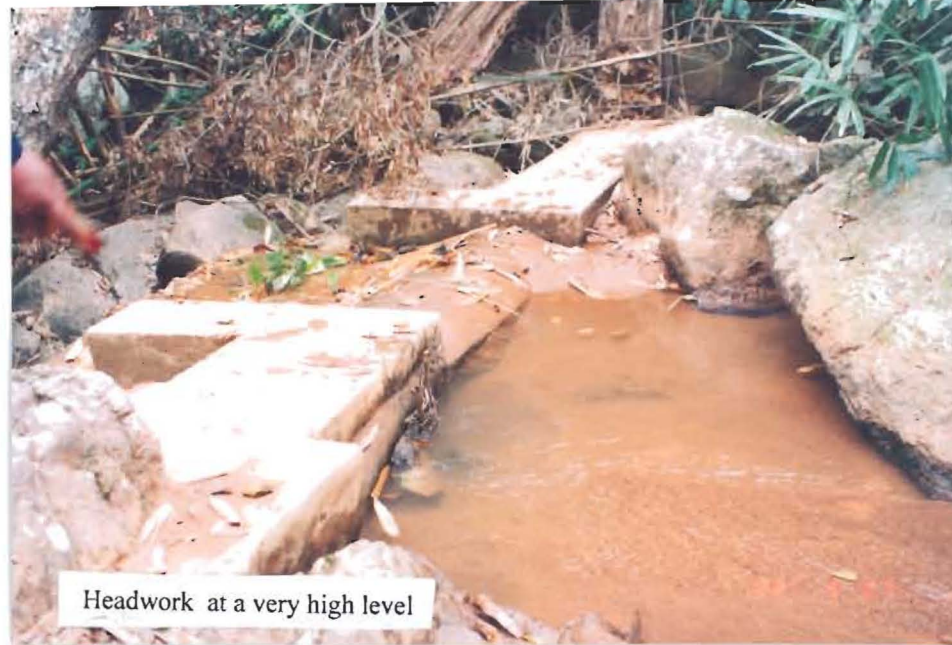
Headwork at a very high level

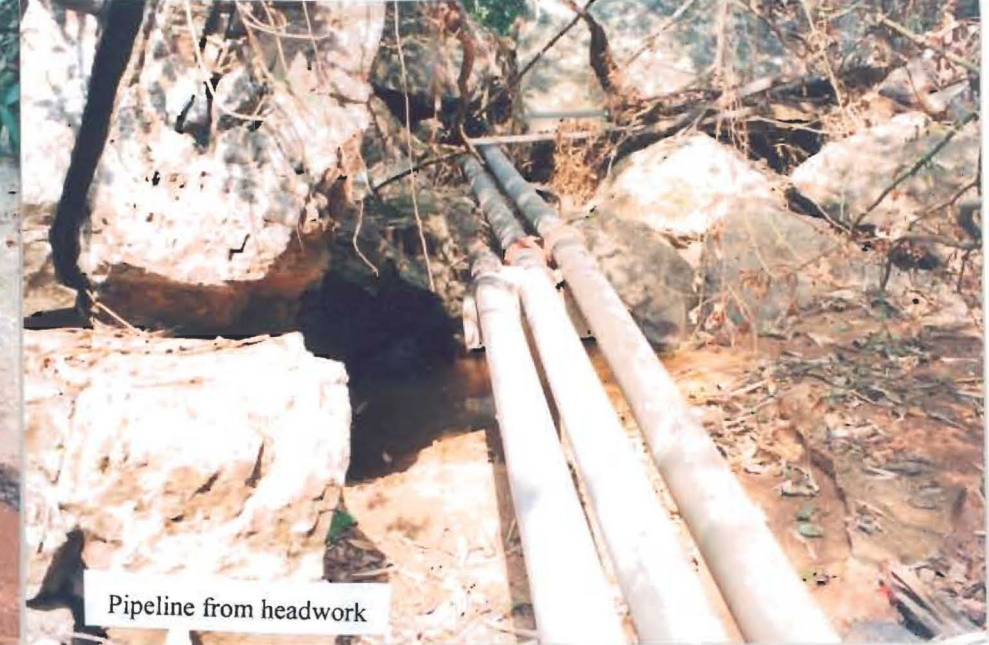
Pipeline from headwork

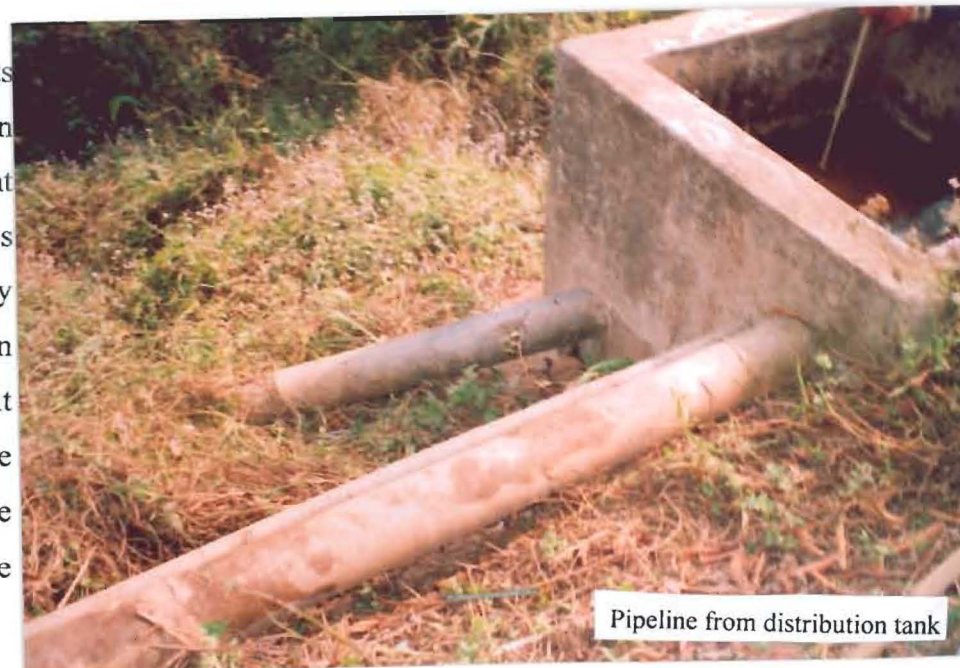
Pipeline from distribution tank

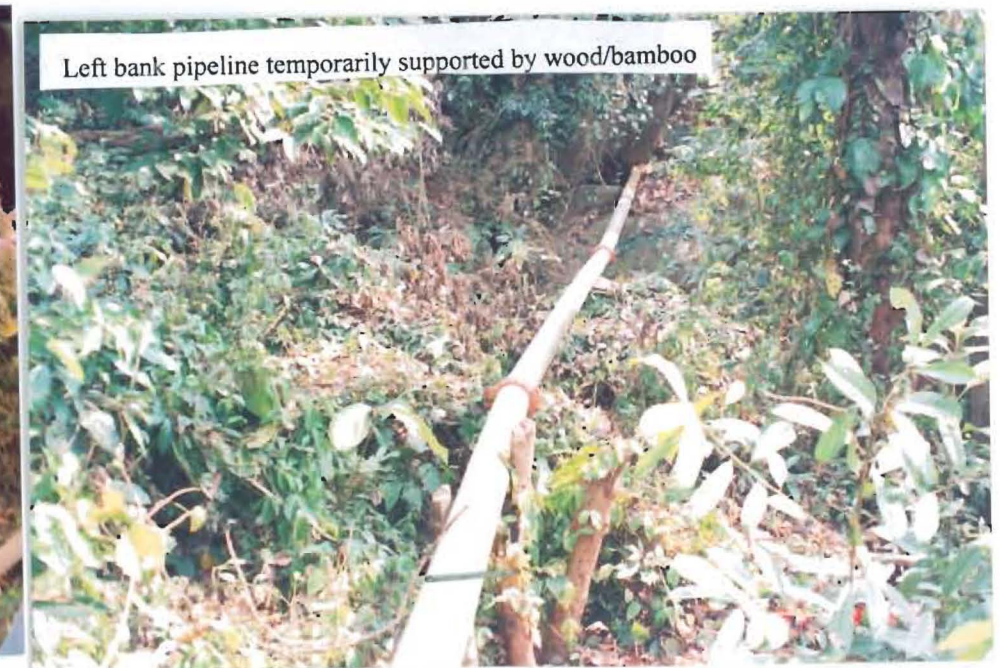
**Left bank:** It is a single pipeline and its length is about 2.00Km. Only a portion of the pipeline is supported by cement pillars and a major portion is temporarily supported by wood/bamboo. Pipeline has also been damaged by wild elephants. As a result of which leakage and breaking of pipe line is unavoidable. The pipeline continues upto the junction where Myntang and Kupli river meets.

Left bank pipeline temporarily supported by wood/bamboo

1. **Only a fraction of the Command area is benefited from the Project.** Though there is a vast potential to develop the area but that will take time. In view of this, Irrigation Department should avoid major renovation.
2. The project is situated in a very interior area bordering North Cachar Hills about 10 Km from Saphai Village. No transport facilities are available. The area is the hideout of militants from across the border and also affected by wild elephants. Local people are easily depending on forest products. A major portion of the command area belongs to people from outside like Raliang etc. This might be the reasons why this area remains barren.
3. Construction of cement pillars to support the pipeline at certain portions is necessary.

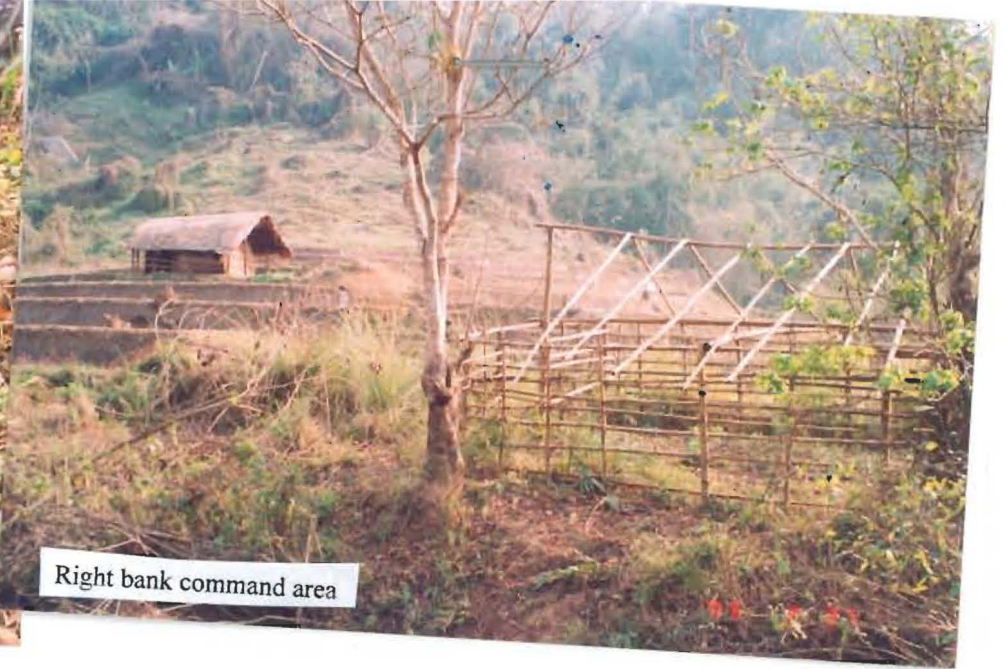
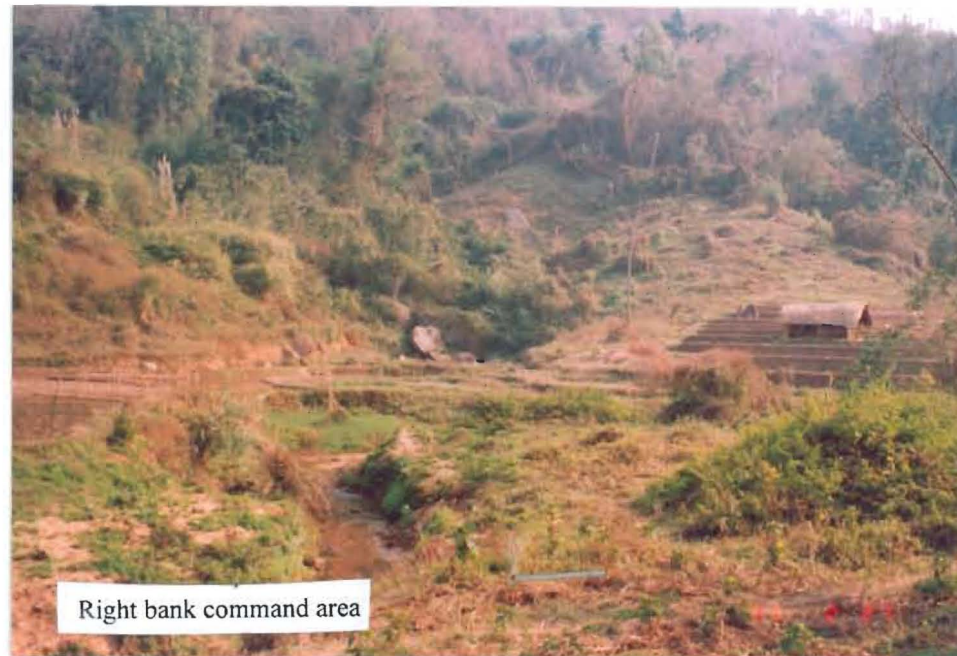
Right bank command area

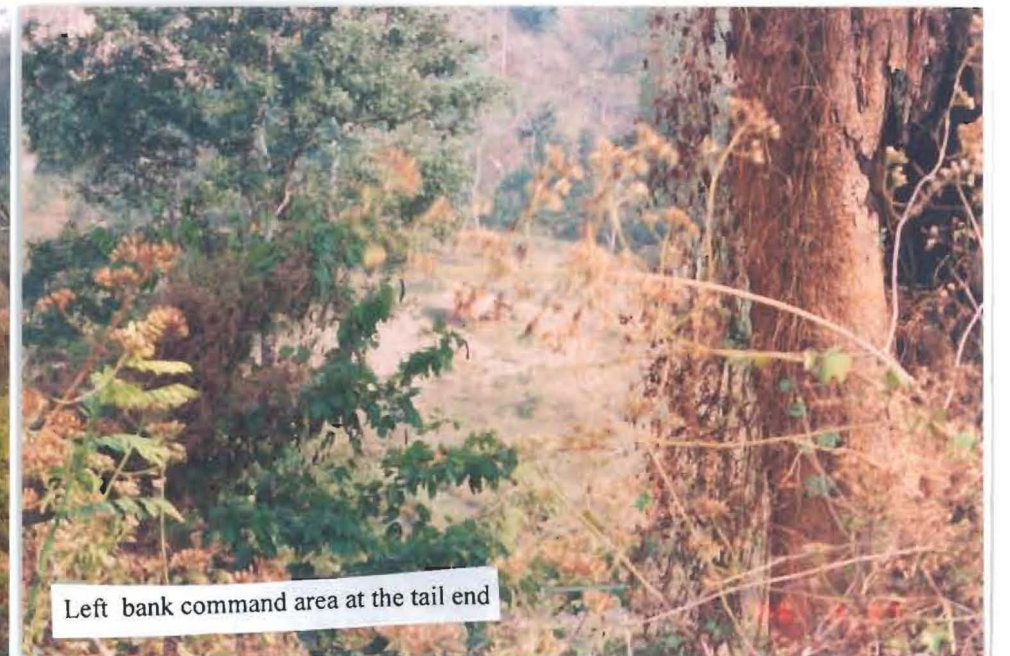
Left bank command area at the tail end

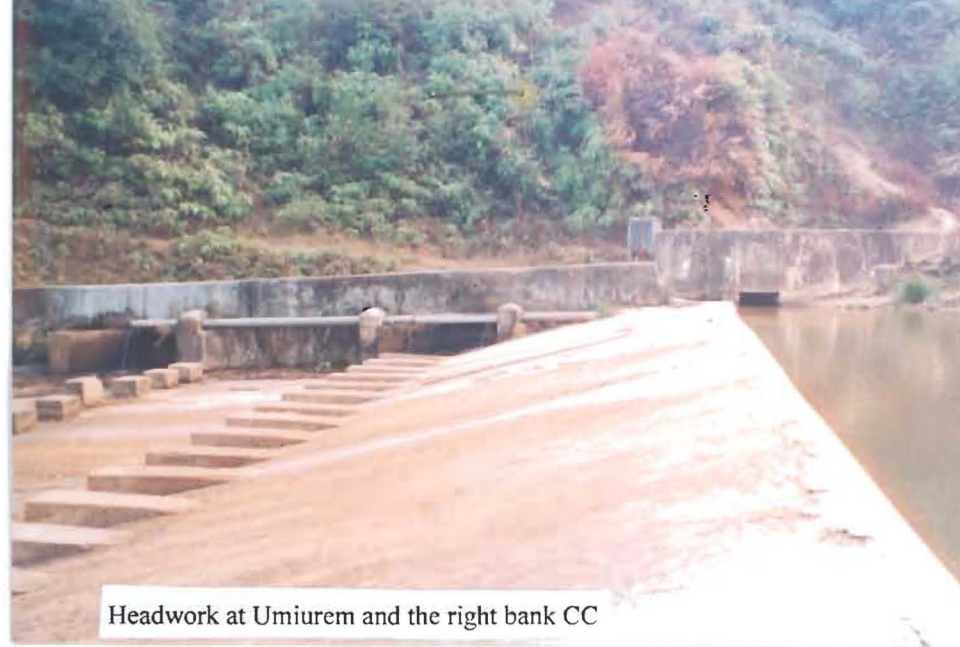
Headwork at Umiurem and the right bank CC

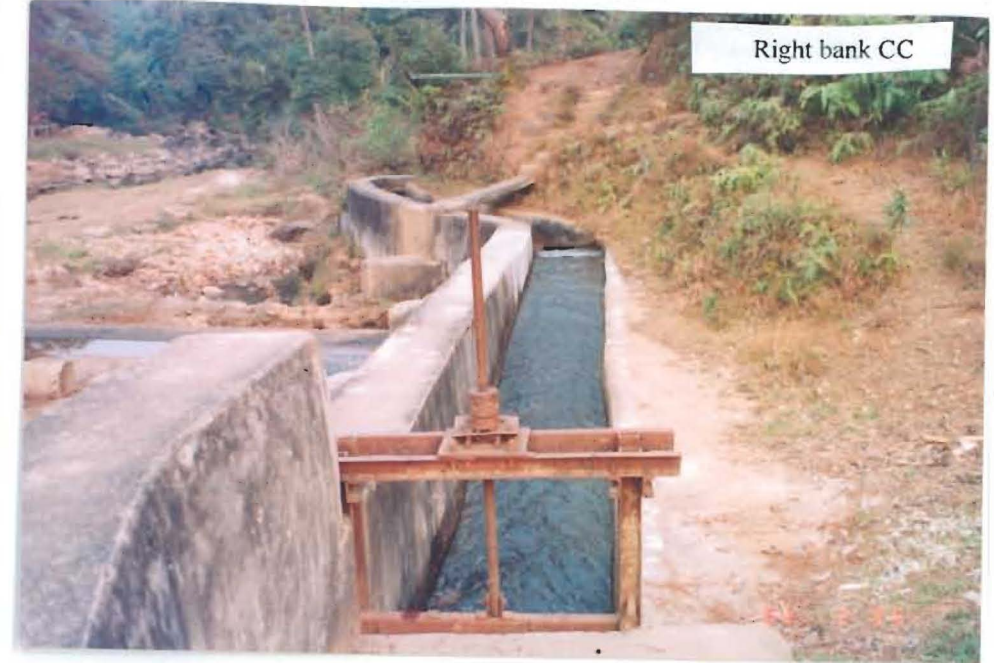
Right bank CC

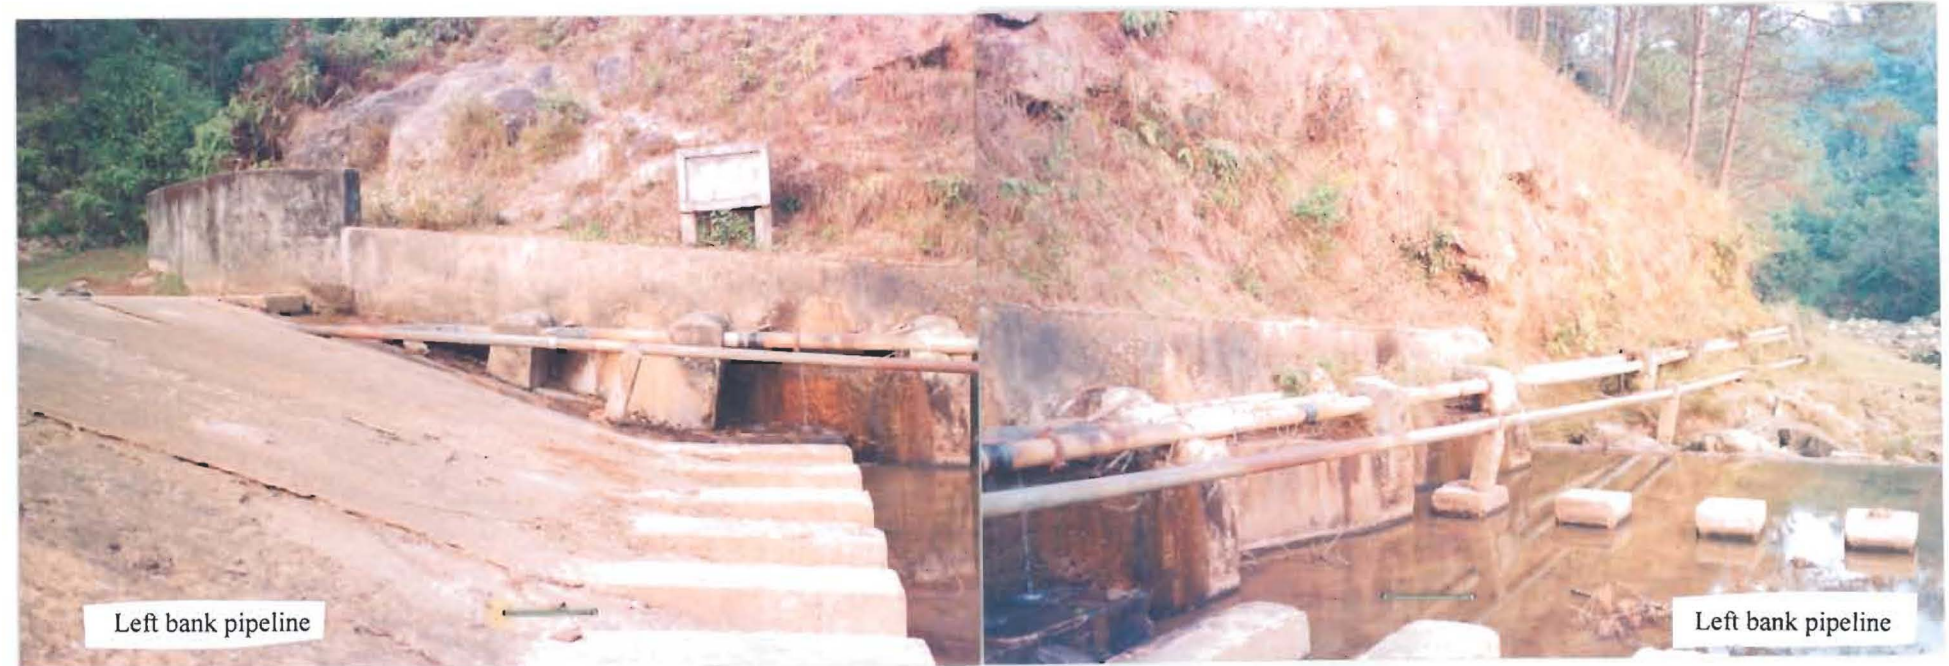
Left bank pipeline
