**Matlang Kdonglapathah FIP**

**TOUR NOTES/INSPECTION UNDERTAKEN BY SHRI.P.L.NONGBRI, SRO AND SHRI.E.B.LYNGDOH, ARO  
IN RESPECT OF IRRIGATION PROJECTS IN JAINTIA HILLS ON THE 24<sup>TH</sup> TO 26<sup>TH</sup> FEBRUARY 2005.**

**IULAMBHOI FIP**

**UMSEMA FIP**

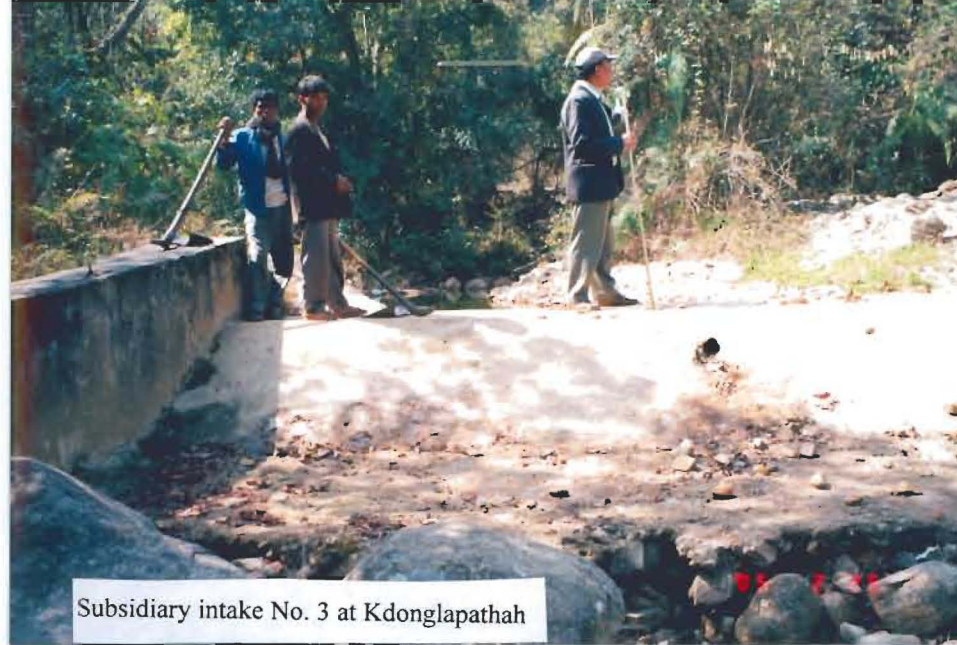
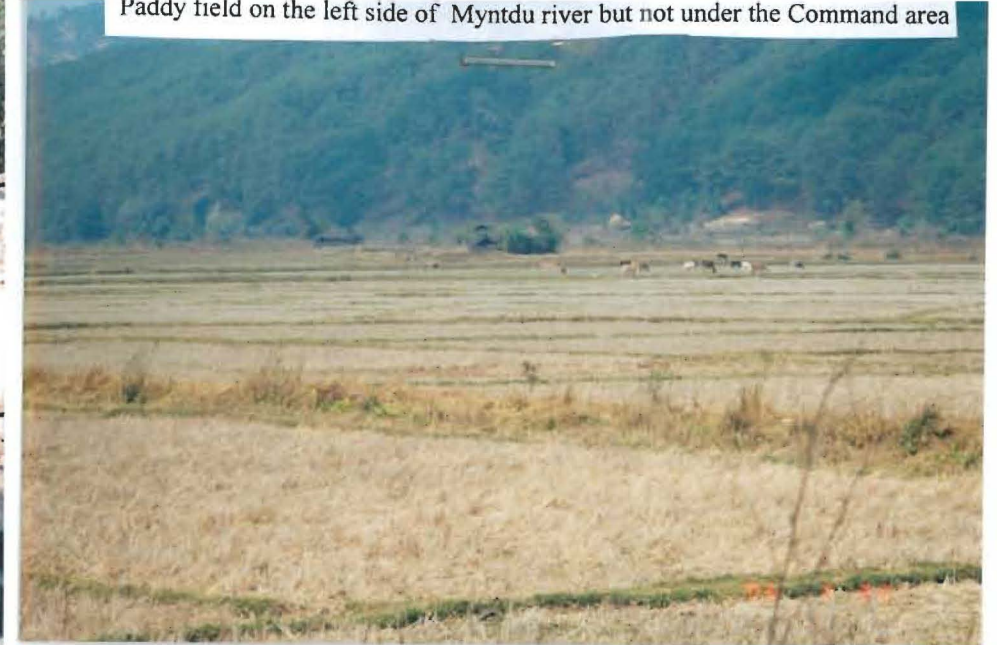
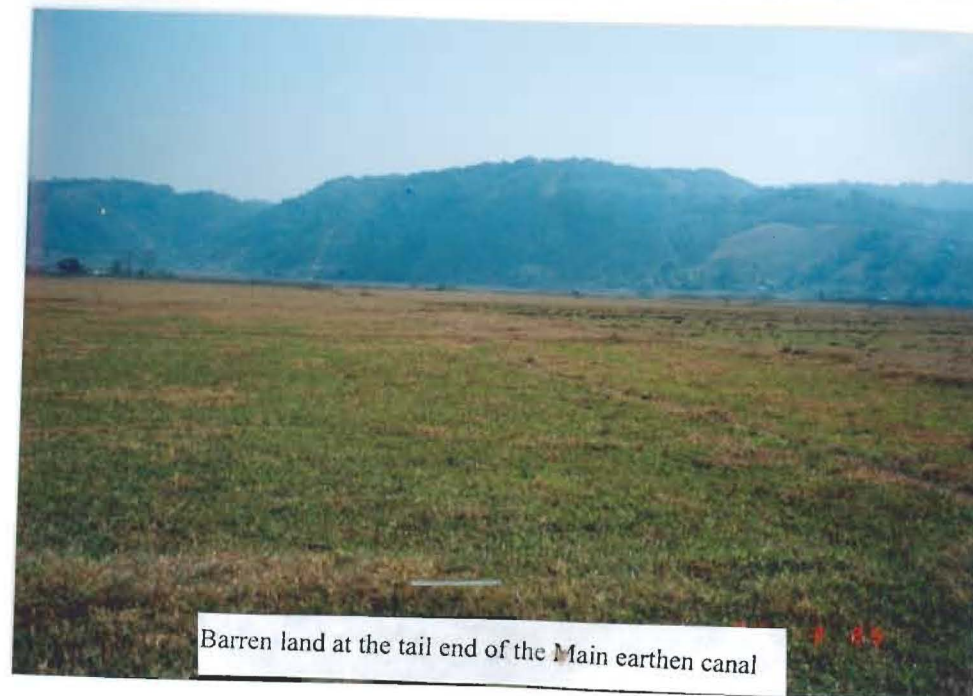
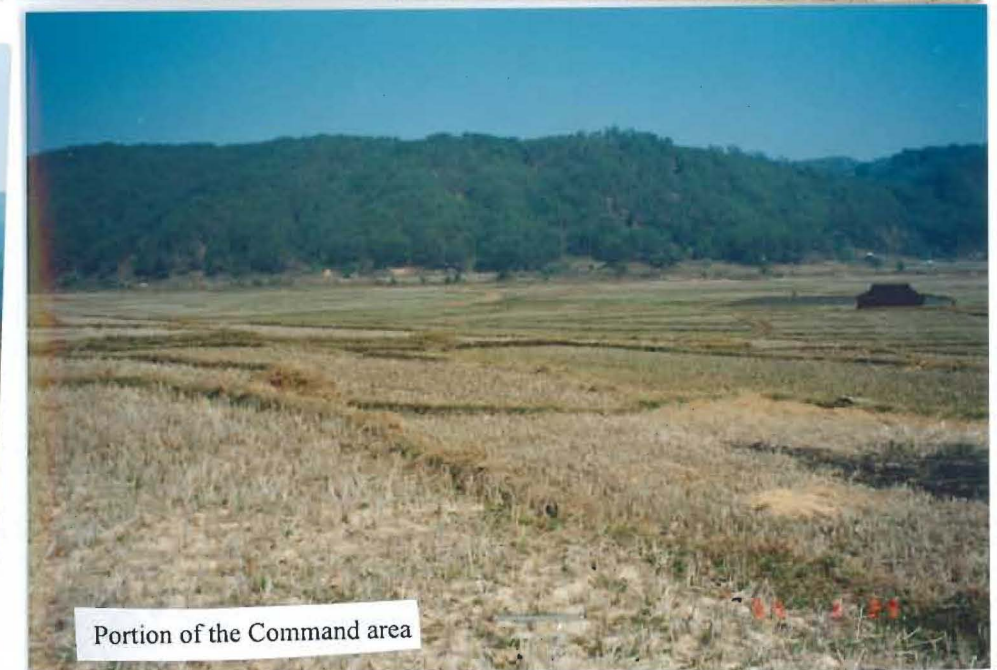
There is no Main Canal from the Headwork

Paddy fields on the left side of the Myntdu river is not under the Command Area and are fed by small intakes/streams on seasonal basis.

5. The Irrigation Department may explore the possibility to construct another main canal from the headwork to the **left bank of the Myntdu River** to feed the barren land and the existing paddy fields.

6. Other sources need to be tapped to cover the barren land of Tre Tangliang, Madan Lyngkien and areas to the **left side** of the Myntdu river.

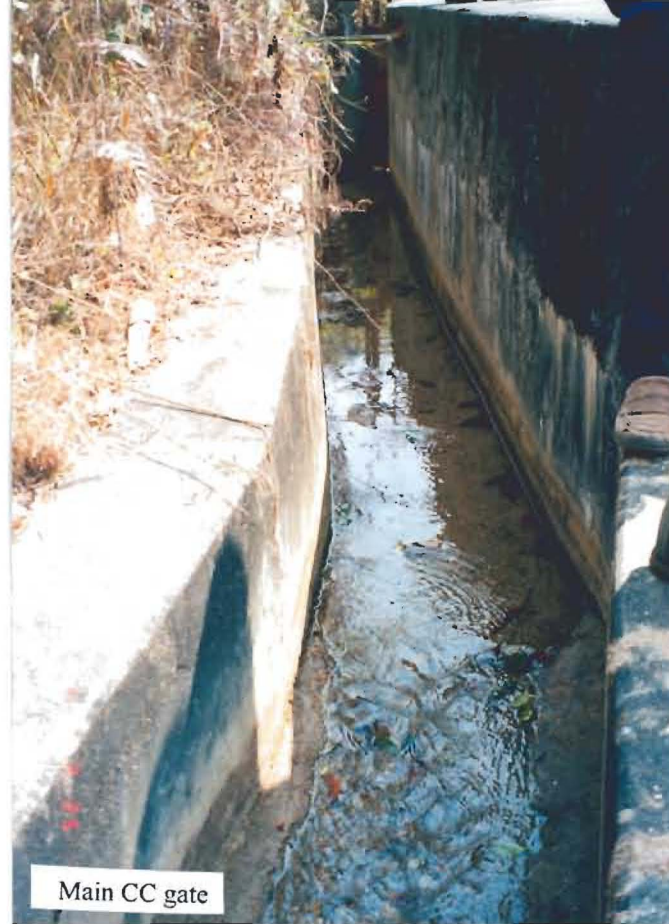
Muster rolls/casual labourers have been engaged on seasonal basis and fund availability. A small amount is sanctioned for maintenance. No maintenance since 2000.

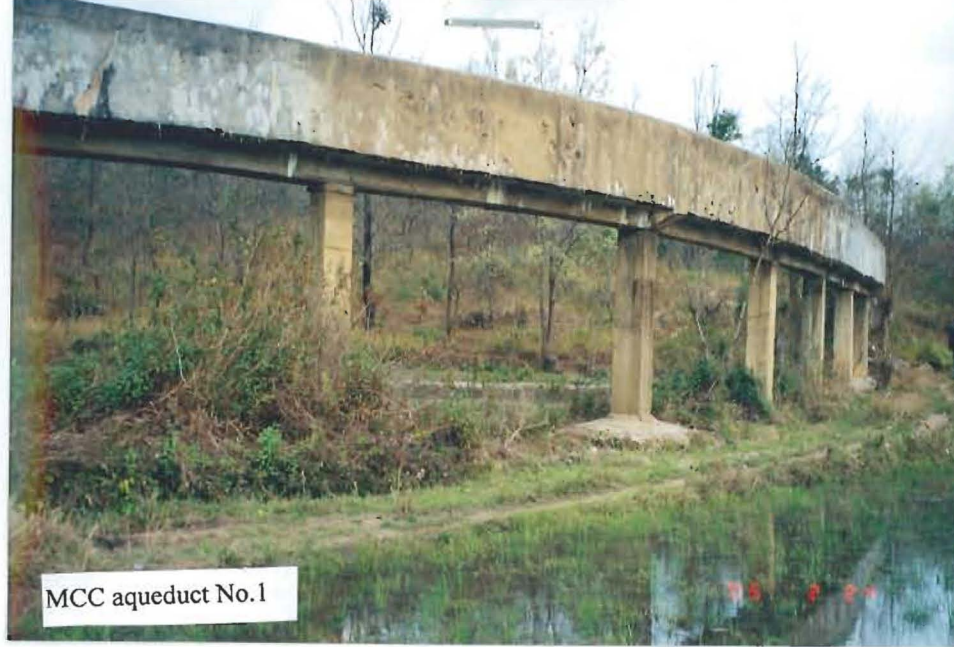
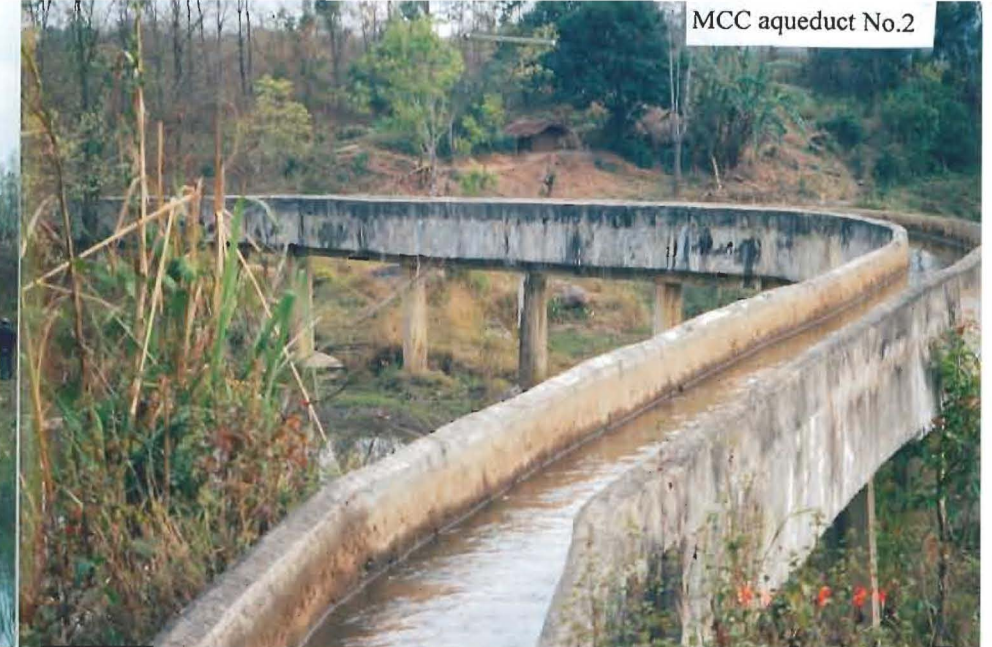
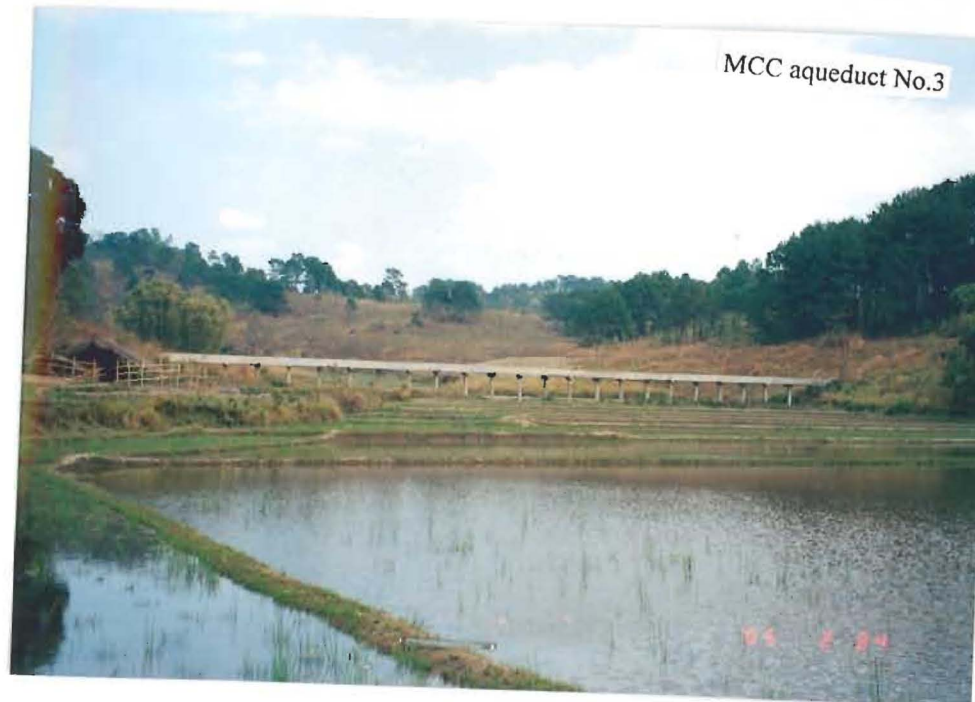
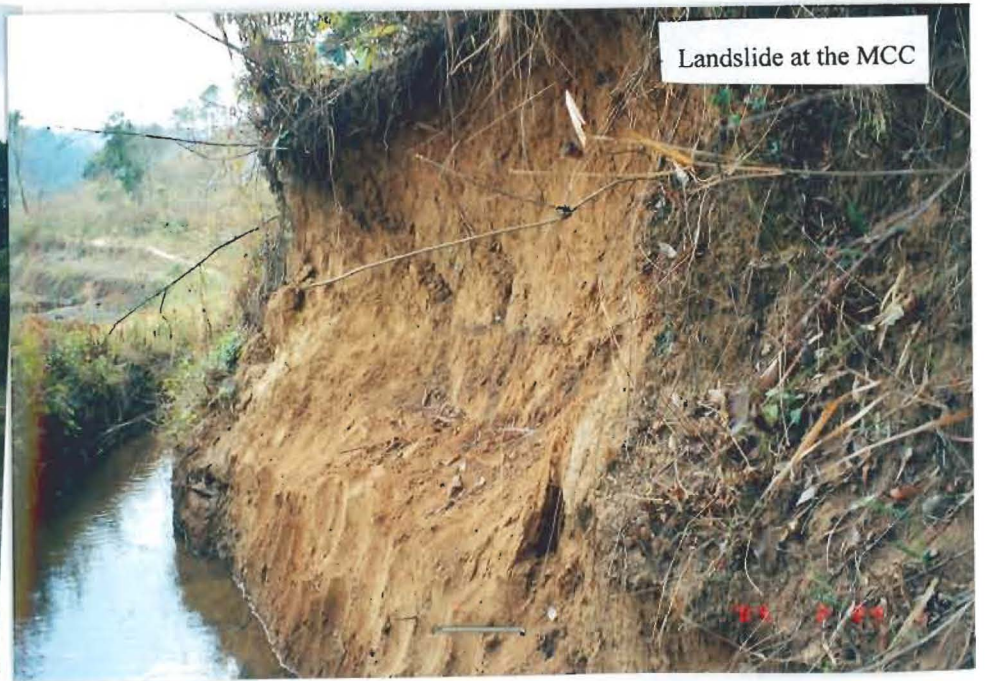
**Left Bank :** There are 3 C.C aqueducts on the main canal and its length is 486 Rm. All in good condition and the flow of water is satisfactory. Certain portions of the main canal have been damaged by the flash floods during October 2004. The water supply at the tail end of the left bank is slightly less due to tampering of the flow of water by the beneficiaries along the line canal.

4. Portion of the C.C damaged due to flash flood should be repaired immediately.
5. Field staff should undertake regular checking/supervision to ensure regular and smooth flow /distribution of water.

6. The flow of water at the tail end of the **left bank canal** should be improved. This matter should be seriously taken up by the Irrigation Deptt and if necessary they may approach the District Administration.

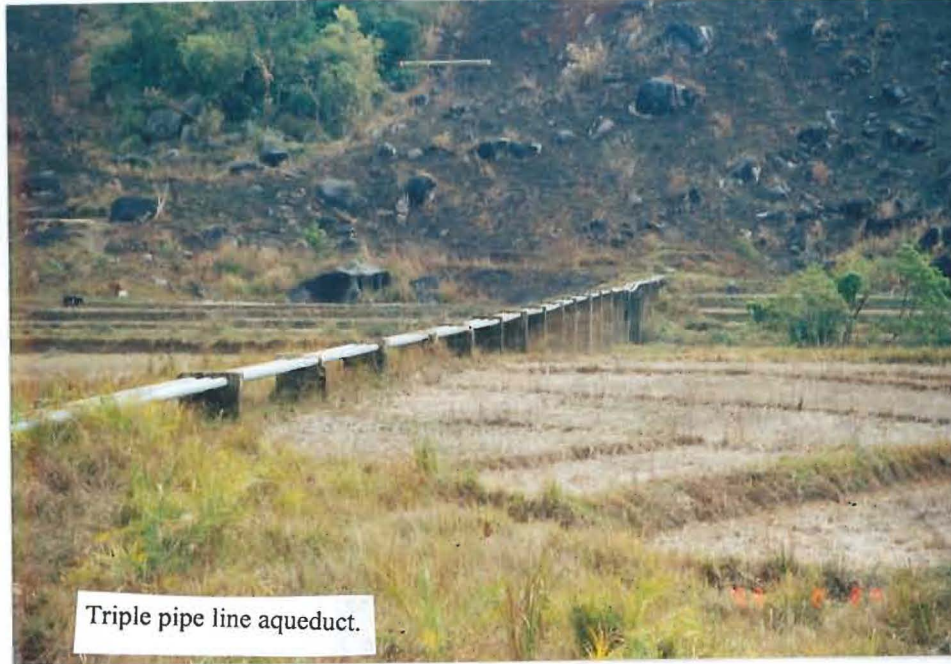
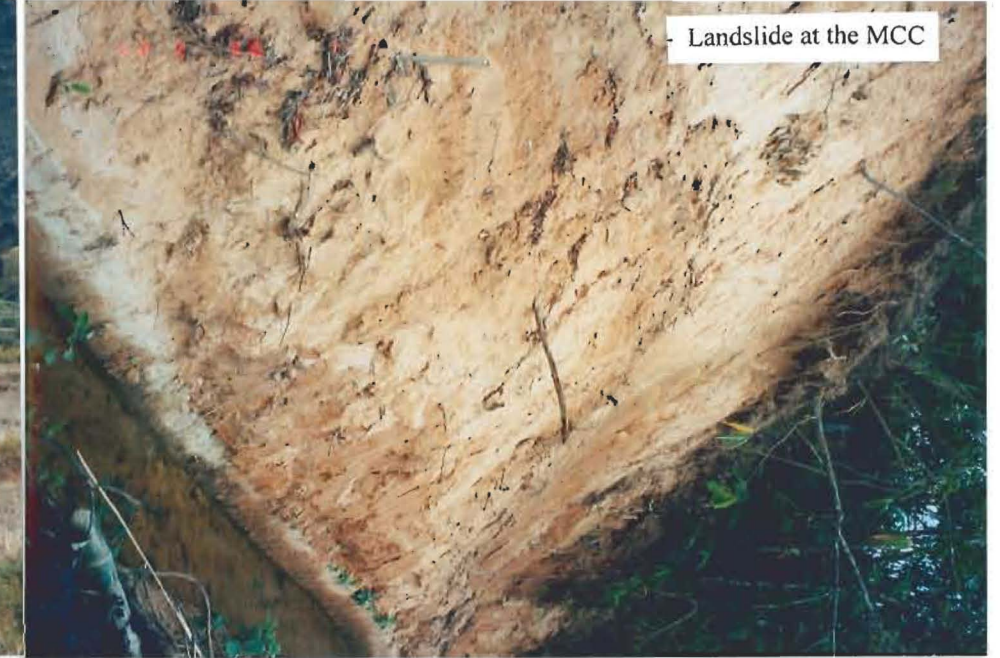
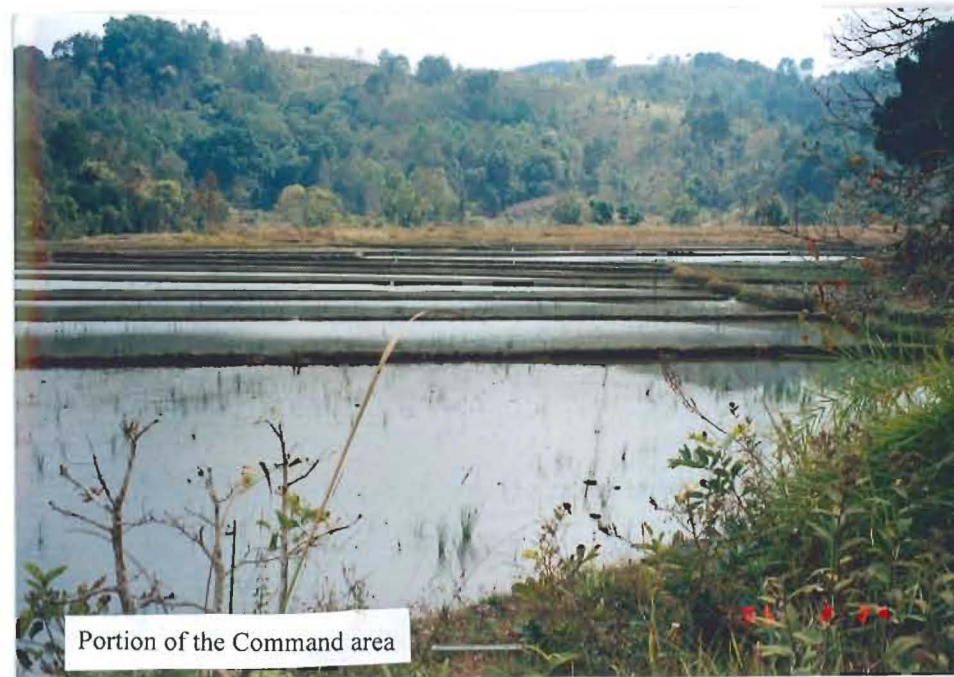
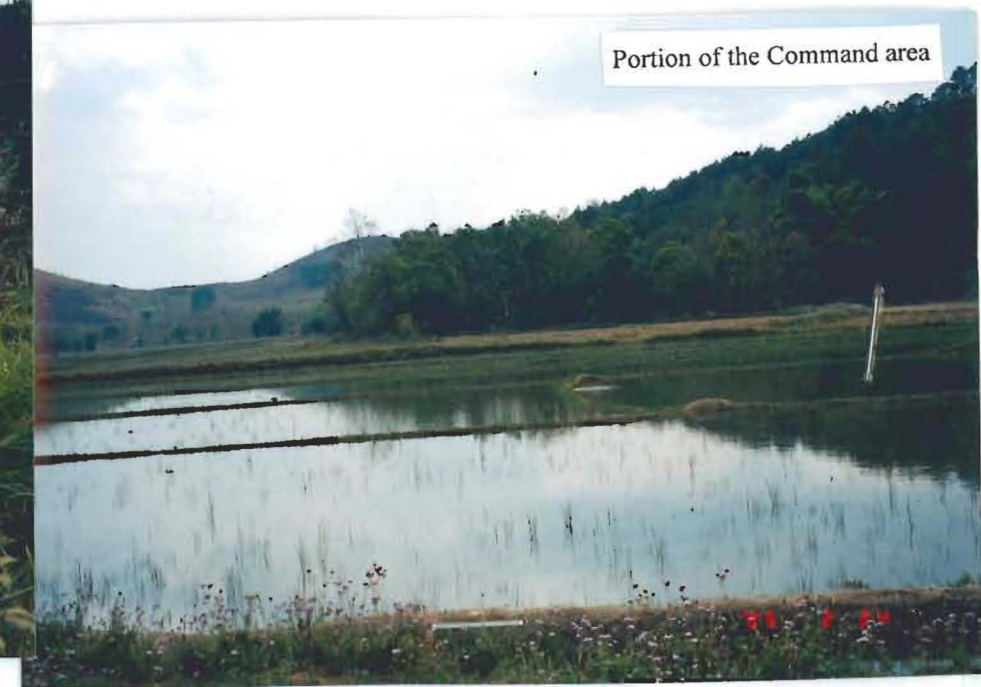
The command areas are well fed by the canals and pipeline except the tail end of the left bank canal.The main crop grown is paddy.

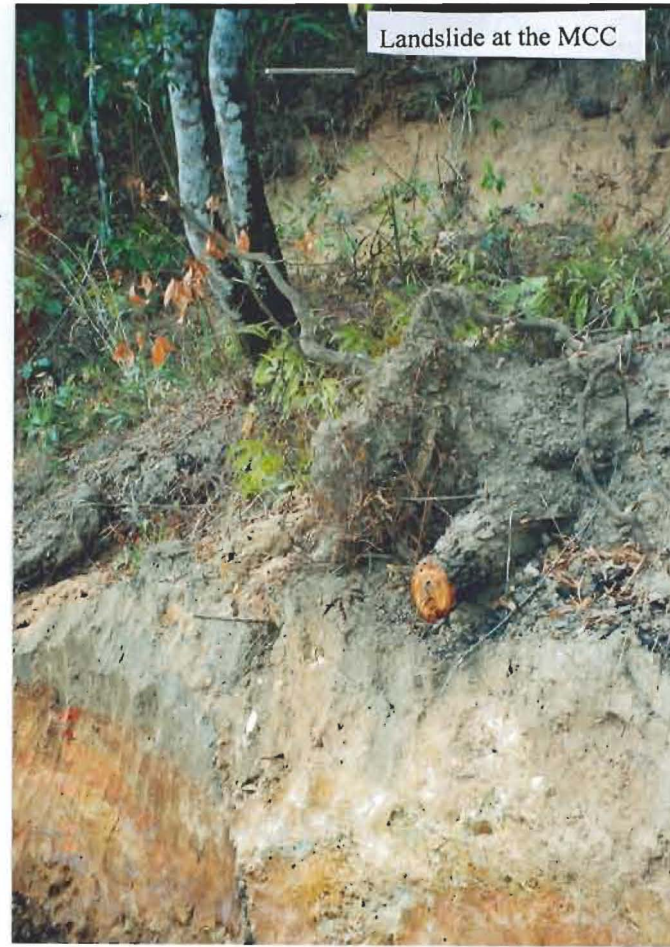
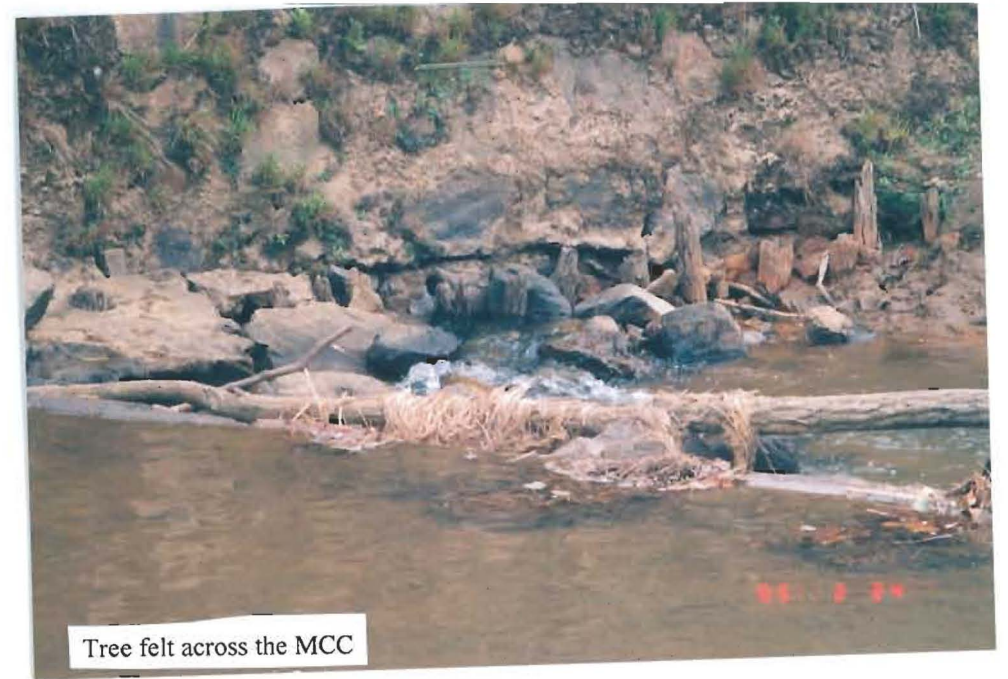
There is only one SA and one khalasi looking after the project but the S.A is also looking after 4 projects. Casual labourers have been engaged on seasonal basis and fund availability. Due to shortage of fund supervision/maintenance has been affected.

1. The project is functioning satisfactorily and more areas other than the targeted command area have been brought under the command area.
2. In view of the difficult topographical terrain, vast area of the command area and fund shortage, maintenance and supervision has been affected. Field staff engaged **for abandoned projects** if any should be utilized for functional and successful ones.

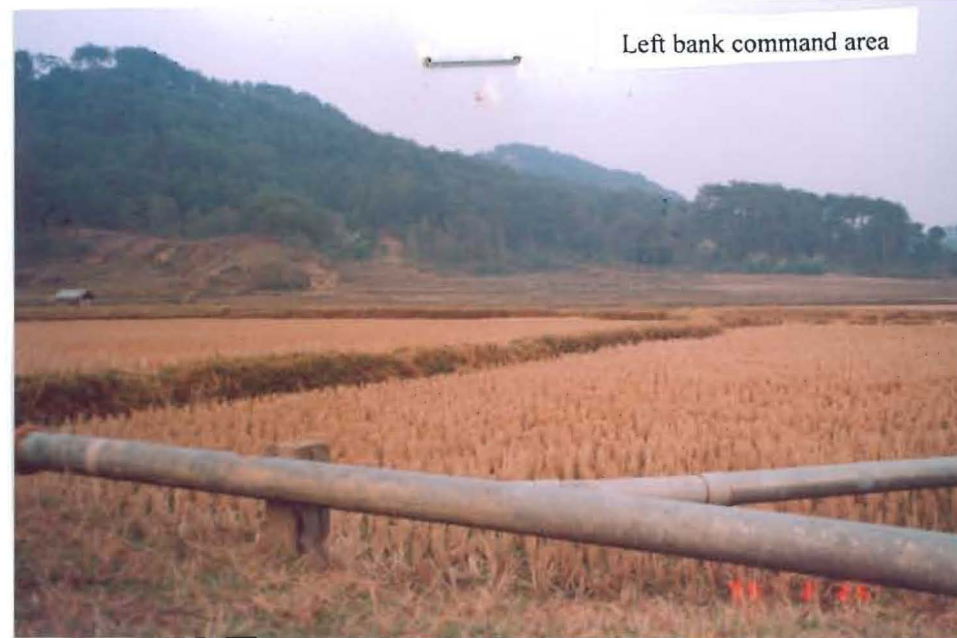
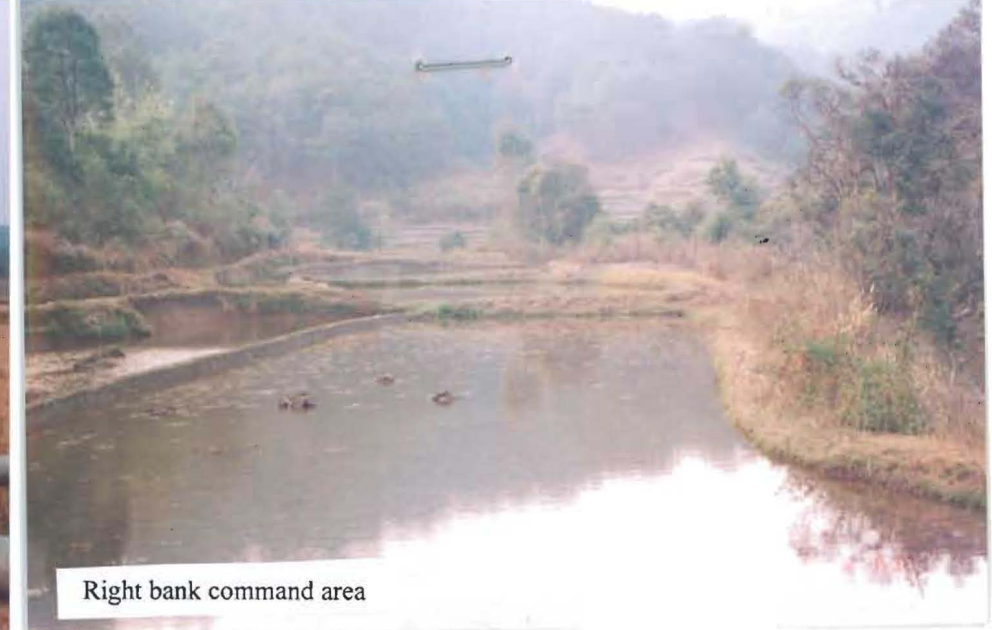
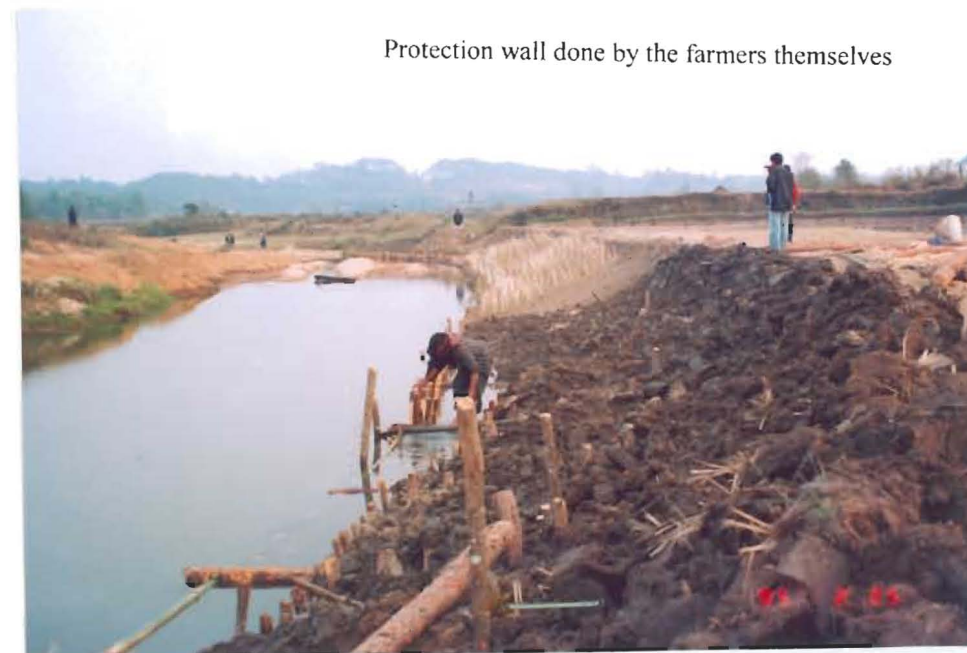
There is only one SA who is looking after other projects also. Limited fund is available for maintenance.

1. The Project is functioning well provided leakages of pipeline and small damages of canals are properly monitored.
2. Water supply at the tail end of the left bank pipeline should be improved.
3. Mouth of the left bank pipeline at the headwork should be properly checked to prevent blocking of pipes.
